# 5

EXISTING BUILDING CONDITIONS

# 5.1 BUILDING ANALYSIS AND SUMMARY

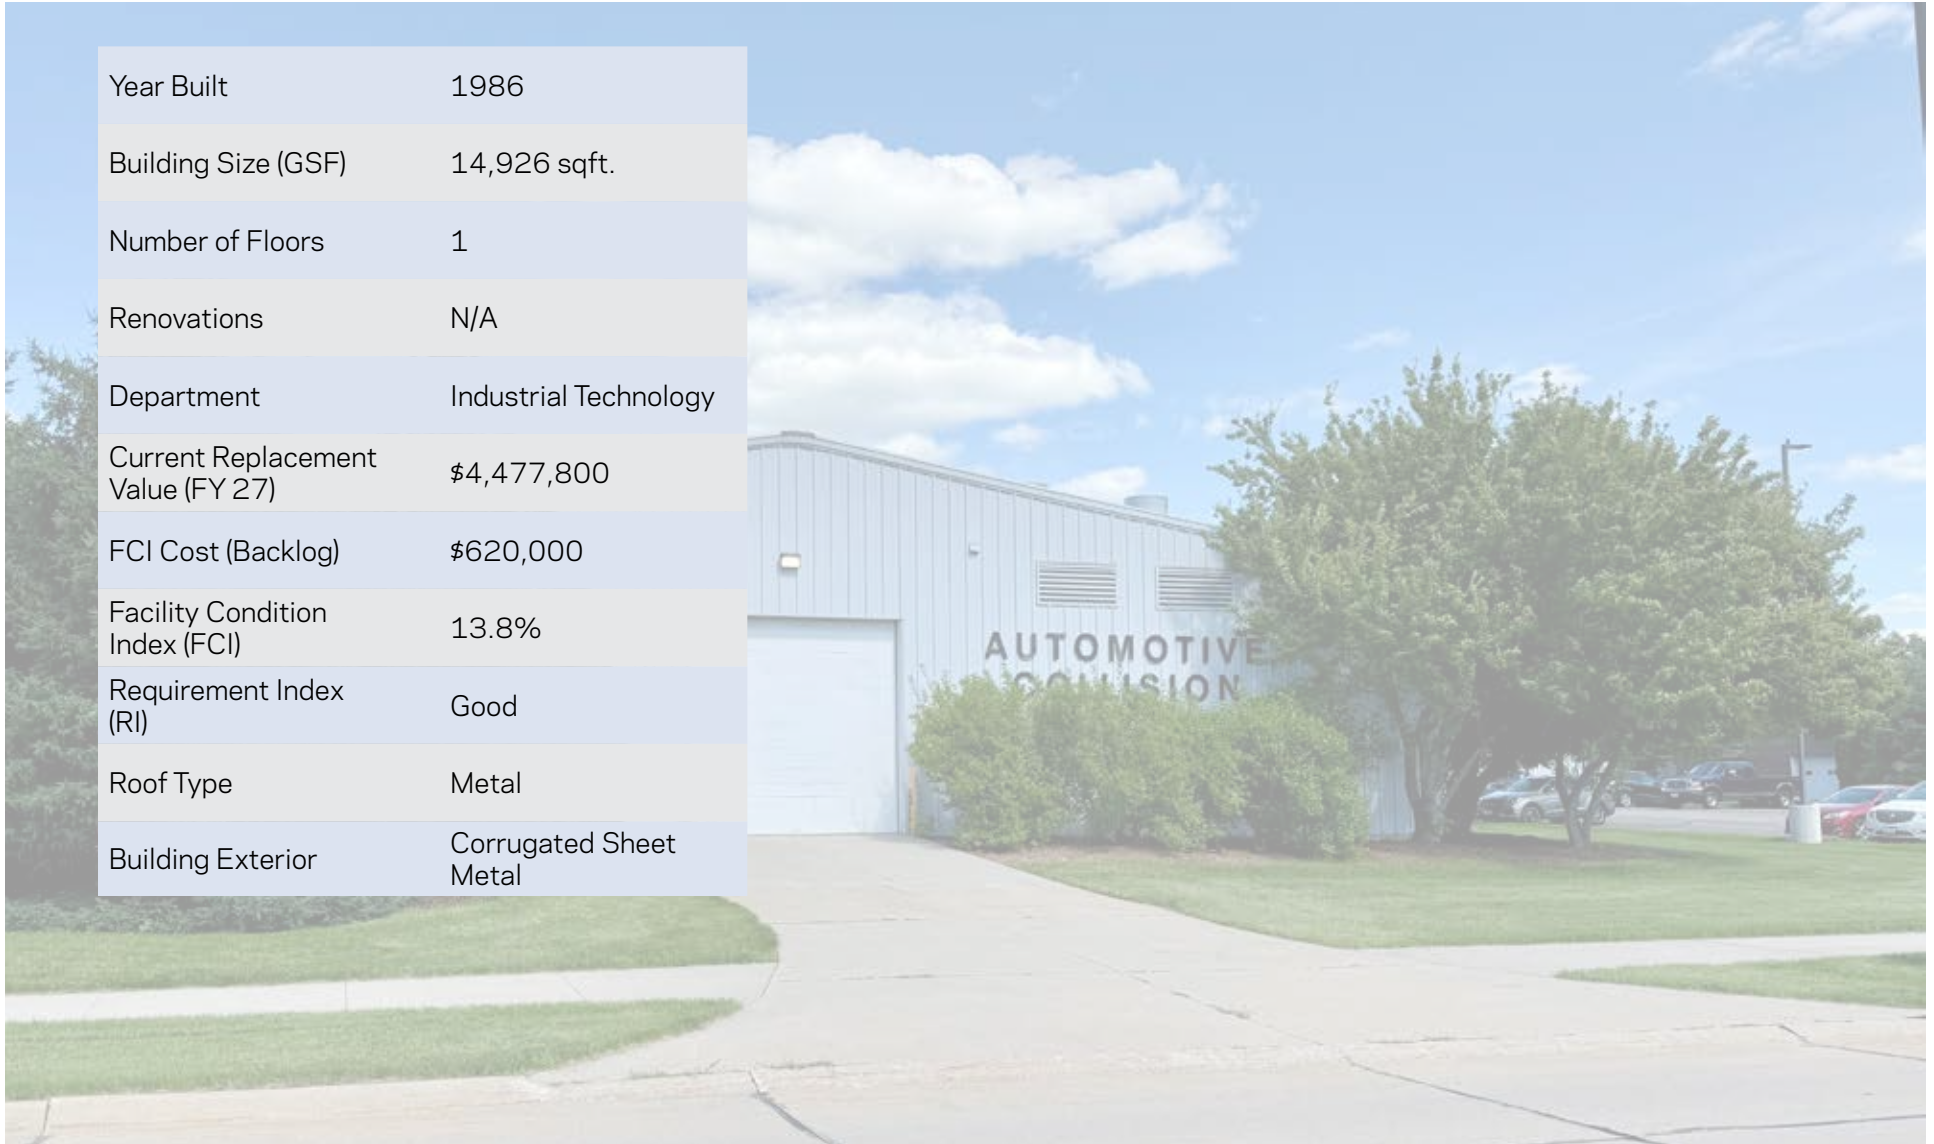
- Building is in poor condition
- Code deficiencies and non-compliant ADA exits need to be addressed
- Currently has newer paint booths in space
- HVAC for classroom and restrooms are nearing end of life and need replacement
- Main electrical distribution panels are original

- Repurpose building for Facilities storage
- Have Auto Collision join Auto Tech at KCETC
- Plan to re-coat roof in next 10 years
- Upgrade restrooms
- Replace exterior car storage

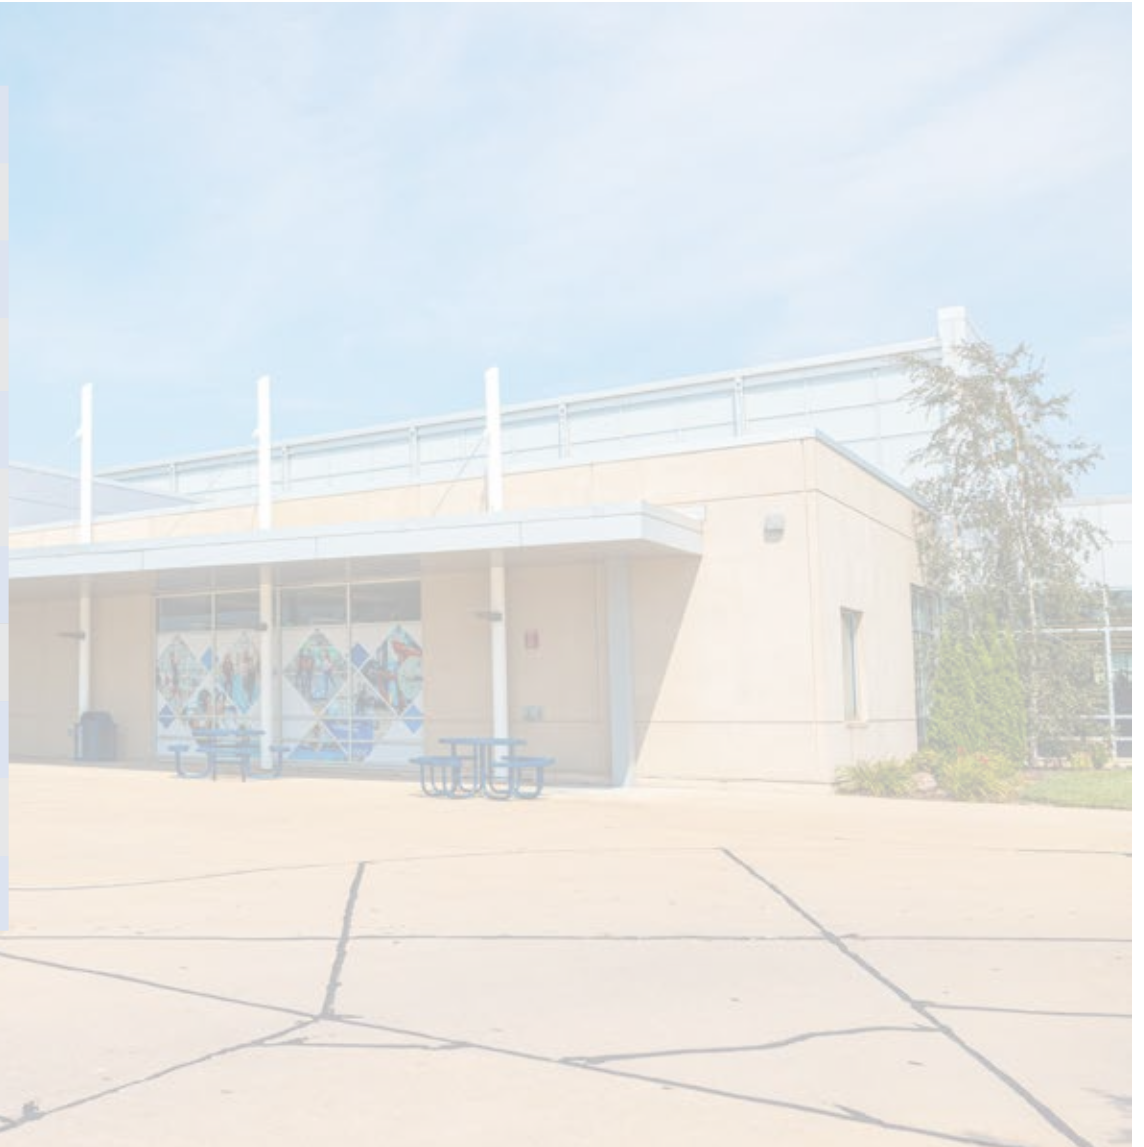
- Interior is in good condition
- Some exterior window issues with cloudy glass/failing seals

- Fix exterior window issues
- Replace track material and basketball floors

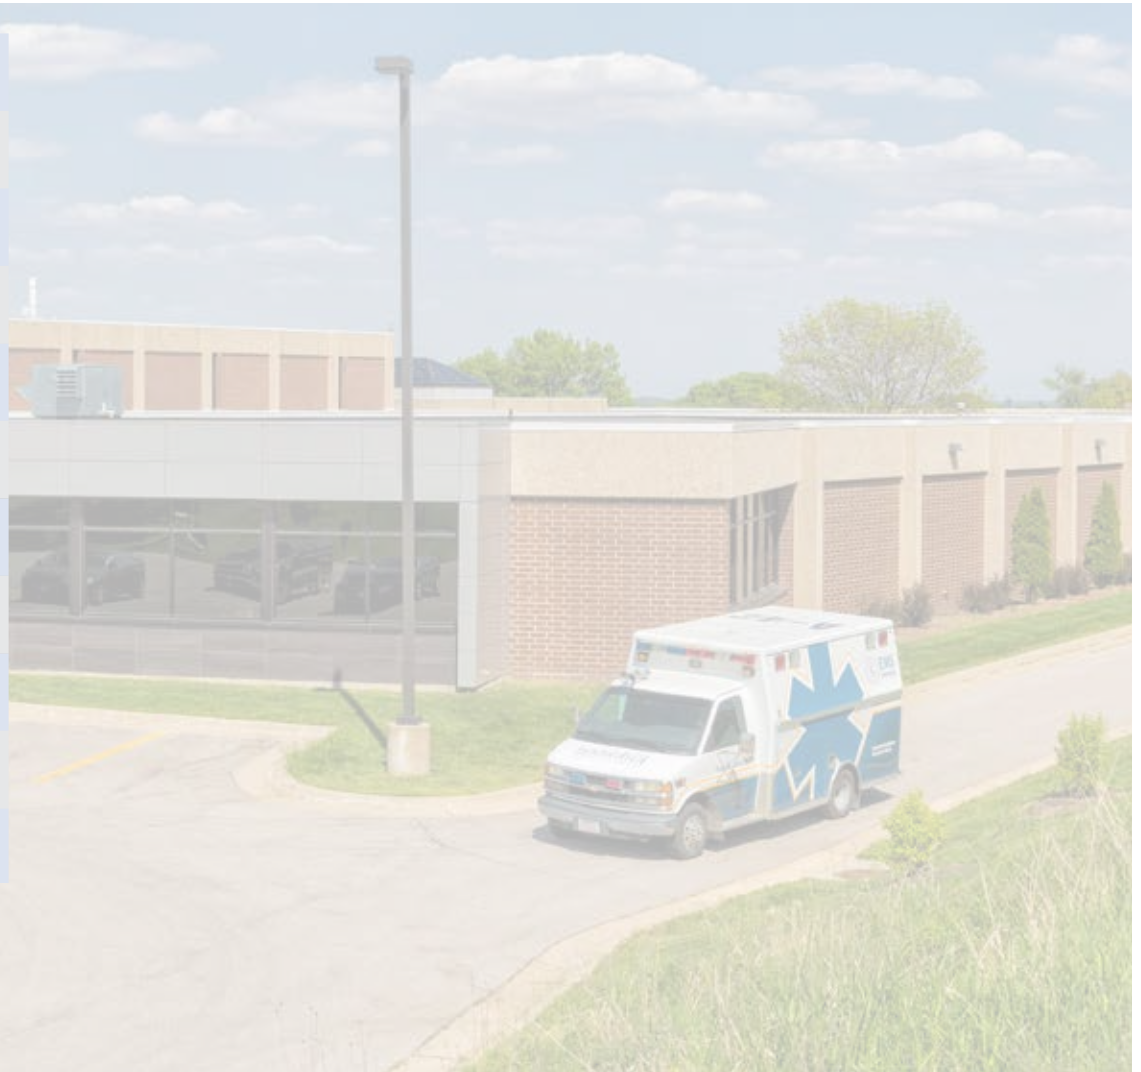
# SIMULATION LAB

- OB and Med Surg rooms are tight
- Acoustic and space separation is challenging between simulation control rooms - both are being run at the same time
- Heat pumps and lighting in renovated areas need replacement
- Critical humidity issues throughout the Sim Center wing
- Heat pump fans/blowers starting to fail, requiring replacement as needed

- Address acoustic issues in control booths
- Create appropriate storage space for mannequins
- Replace energy recovery unit to improve dehumidification capabilities
- Office and lobby area can be reconfigured to simulation labs to accommodate future expansion. Offices can be located in adjacent Linn Hall space.
- Repair foundation water infiltration issues
- Replace failing heat pumps
- Upgrade flooring
